SOUTHERN UPLAND WAY

Notes on multi-use access

Updated March 2017

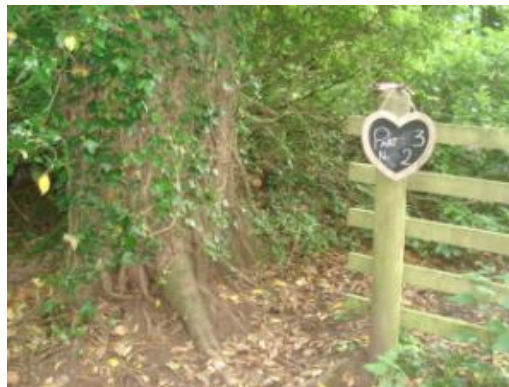
At NX116608 there is a 2-in-1 gate. The main gate is padlocked and the integral 0.74m wide pedestrian access is too narrow for a horse. There is a 0.81m gap (pictured below) between the fence and tree alongside the gate but most horses would struggle to squeeze through this gap.

It may be possible to avoid this obstruction on tracks to the north, using the gap alongside the gate at NX116607 to link with the core path to Balker Bridge, turning east again to rejoin the Southern Upland Way at East Lodge, but there is a metal vehicle barrier across the track just west of the lodge. Overhanging branches may require dismounting to get around the gap to the side of the gate.

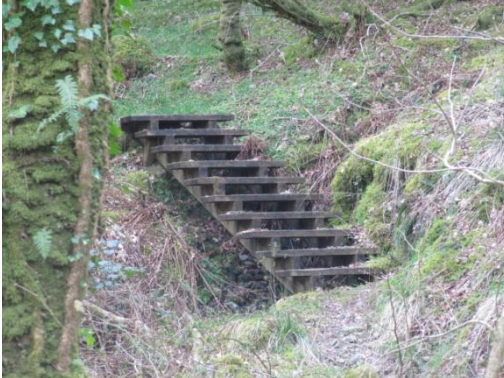
Location / OS Grid Ref.	Feature/description	Alternative access to avoid restrictions
NX170616	Steep ladder steps up bank

None in line of path – steep wooded bank, no space or scope to pass alongside. Use minor road between Coburn Bridge and New Luce.
NX171617	Kissing gate leading onto bridge across burn. Bridge passable but kissing gate impassable with a horse.

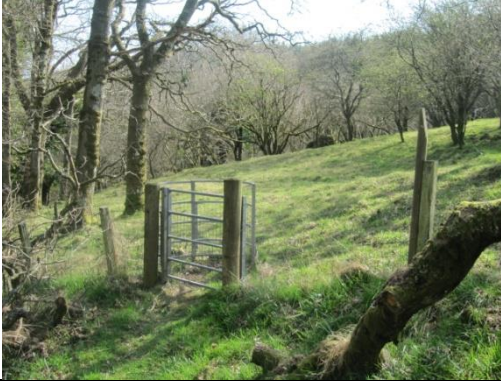
<p>NX170623</p>	<p>1.5m metal bridlegate leads onto series of shallow steps down onto bridge over railway, further bridlegate and steps at eastern end. Passable with a horse with care</p>

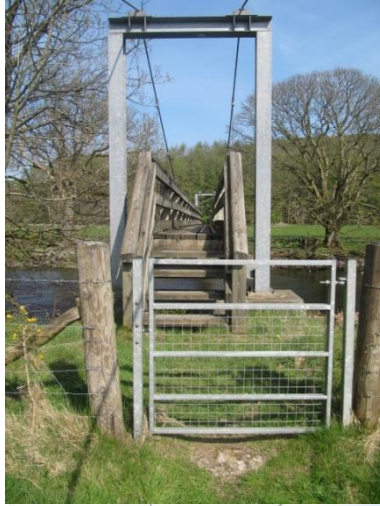
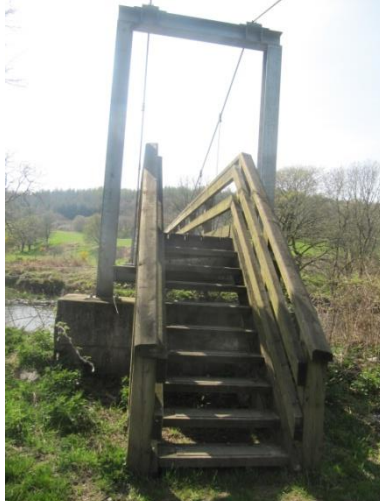
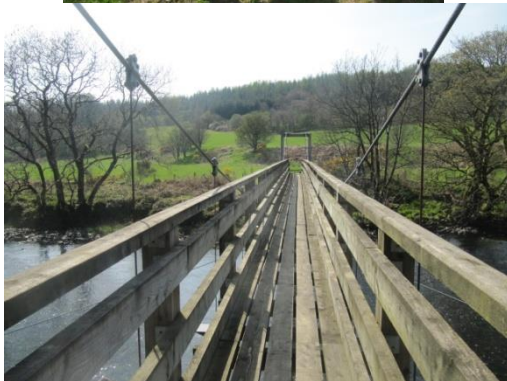
<p>None</p>
<p>NX173621</p>	<p>Metal bridlegate in fence leads onto steep steps up onto narrow, very</p>	<p>Impassable with a horse, difficult with a bike. River not particularly</p>

wobbly pedestrian only suspension bridge over river, insufficient load bearing capacity other than walkers, steps down at eastern end – impassable with a horse

deep, easy to access from east side, but no entry/access on steep wooded west bank, and no gate in fence parallel to river to allow fording or exit from the river further up or downstream. Use minor road from Coburn Bridge to New Luce

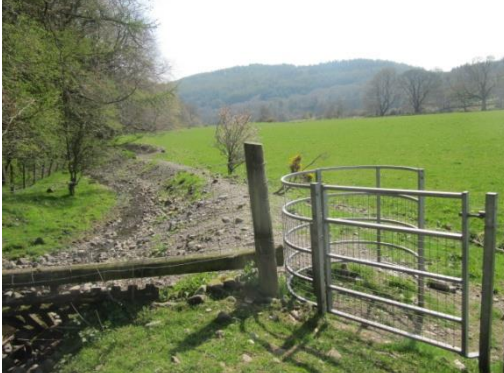
NX173622

Kissing gate in stock fence

Field gate 50m along fence to north

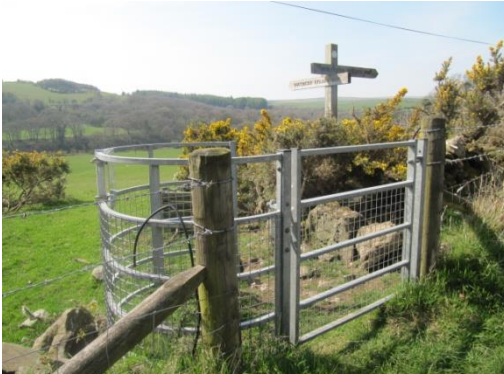
NX175624	<p>Kissing gate at junction of SUW with road</p>

<p>Field gate 50m west down fence, across burn, to further field gate at NX175621, then further field gate adjacent onto public road</p>

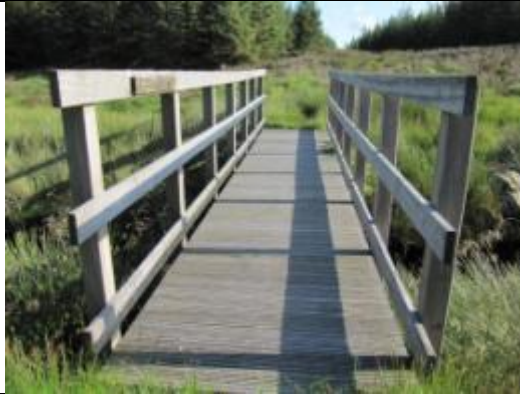
NX223717	<p>Locked barrier across bridge on west side of burn</p>

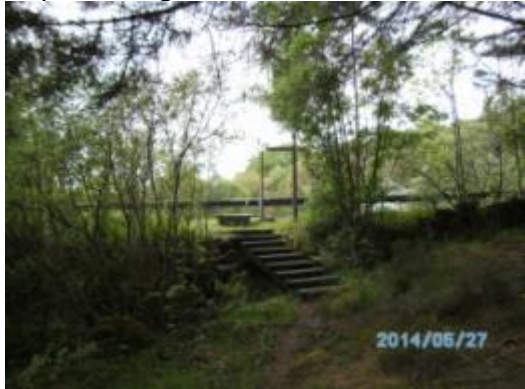
Location / OS Grid Ref.	Feature/description	Alternative access to avoid restrictions
Bargrennan	<p>Metal roadside barrier followed by steep steps leading down bank into woodland</p>

Follow A716 south to Clachaneasy
Bught Hill	SUW passable with care on cycle or with horse from Clachaneasy Bridge to next road junction (but see below- route beyond impassable)	Follow public road from Clachaneasy Bridge to Stroan Bridge
Clachaneasy Bridge to Glen Trool	Numerous stiles, footbridges, narrow insecure boardwalks and sections of narrow, boggy path make this section impassable on a bike or with a horse. Although the forest road is passable up to the turning circle at NX371766, there is no facility on from there.	Follow public road to visitor centre at Stroan Bridge, then turn right (east) continuing on tarmac road to Loch Trool, and waymarked cycle route along firm track to rejoin SUW at Glenhead

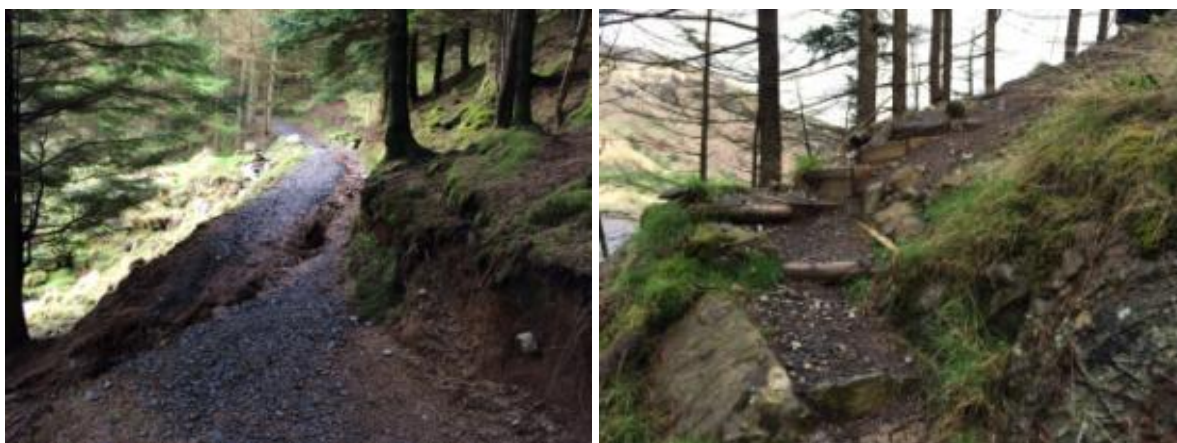
The waymarked Southern Upland Way along the south side of Loch Trool is in theory passable on cycle or horseback but at time of survey in summer 2014 was blocked in places. A new path surfaced with sharp stone is passable on foot but may present some issues for cyclists or horse-riders where it has suffered serious water erosion (NX420798) and where there are steep steps (NX422798).

The easier route for cyclists and horse-riders follows the tarmac road and then waymarked cycle route around the north side of the loch, rejoining the Southern Upland Way at Glenhead over a vehicular bridge. East of the bridge, hard sharp stone surfaced forest road continues all the way to Clatteringshaws. In several places gaps have now been left alongside vehicle barriers, in place of former kissing gates. Elsewhere 2-in-1 gates incorporating a pedestrian gate, but the main gate is unlocked hence passable with a bike or horse.

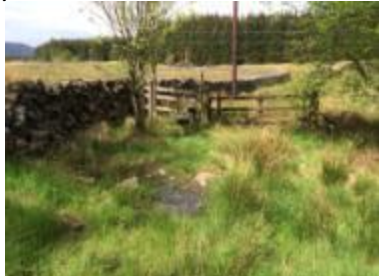
Location / OS Grid Ref.	Feature/description	Alternative access to avoid restrictions
NX539790	Wooden slip-gate adjacent to stile, passable dismounted

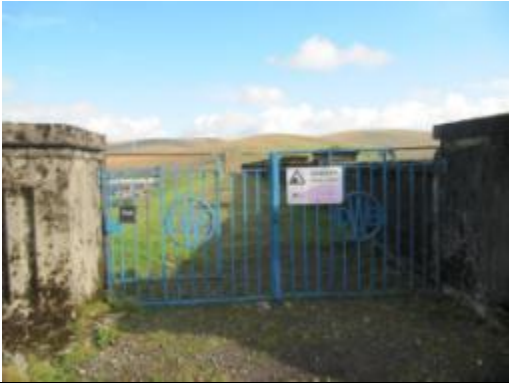
Location / OS Grid Ref.	Feature/description	Alternative access to avoid restrictions
NS970091	Pedestrian only step-over in locked gates either	Follow original route of

<p>end of dam over Daer Reservoir</p>

<p>SUW as marked on OS map rather than new waymarked route, turning left at junction of track through Watermeetings Forest and public road, over bridge, then right, through gate next to cattle grid, then left alongside fence (not waymarked)</p>
<p>Sweetshaw Brae NS986095</p>	<p>Boggy peat with some sections of slatted boardwalk, passable in dry weather but then meets ladder stile in dyke on southern side of Sweetshaw Brae</p>

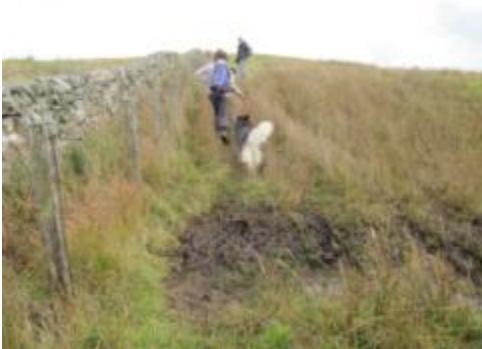
<p>Slip hurdle in fence at approx. NT994097 but ground very boggy on north side of dyke</p>
<p>NT989096</p>	<p>Step over stile in fence followed by more peaty bog with open ditches</p>

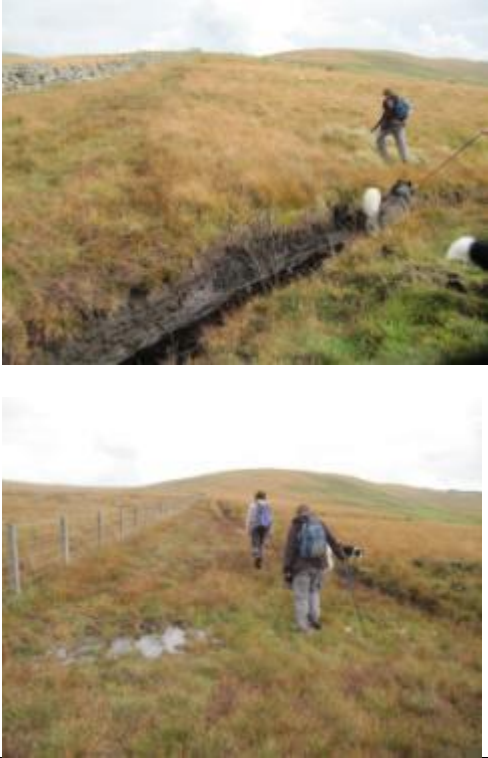
<p>Stile in fence, followed by more boggy ground</p>

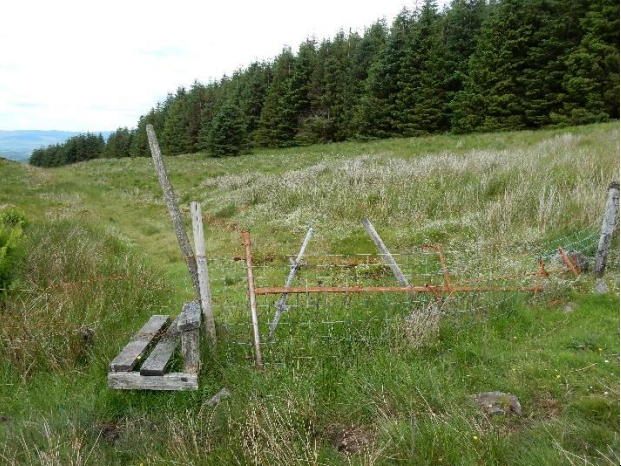
<p>None other than dismantling fence. Original gateway wired across</p>
<p>NT014074</p>	<p>Windblown trees for several hundred metres across path</p>	<p>Walkers have beaten a narrow path through bracken parallel to path, boggy in places and difficult for horses to see</p>

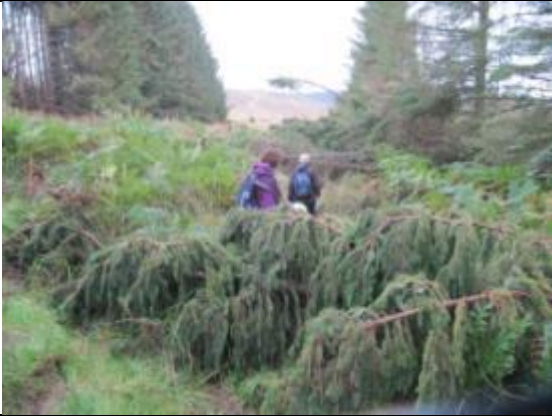
their footing
<p>NT019070 (approx.)</p>	<p>Serious erosion/landslip/wash out in line of path at burn crossing, passable with care Oct 2014</p>

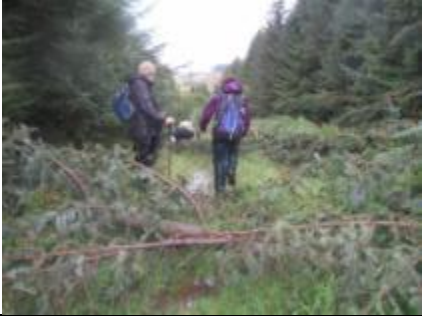
<p>None. SUW runs between tall conifers either side, ground off the line of the path (and sometimes on the path) very boggy</p>
<p>NT037049 North of Birkie Know</p>	<p>Narrow wooden footbridge, fallen trees across one end</p>	<p>Former ford 20m upstream of bridge</p>

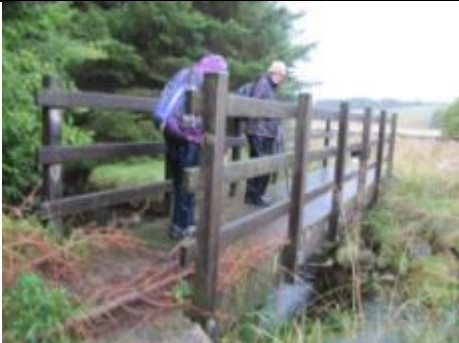
<p>NT037048</p>	<p>Boggy ground, various slatted wooden boardwalks in line of path</p>

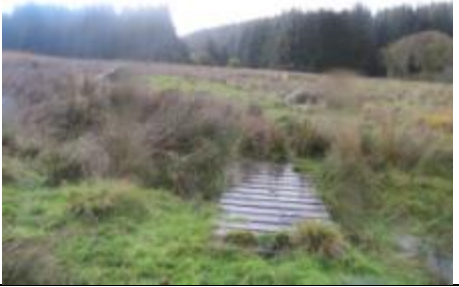
<p>None</p>
<p>NT039046 Foy's Bridge</p>	<p>Narrow wooden footbridge with steps either end</p>

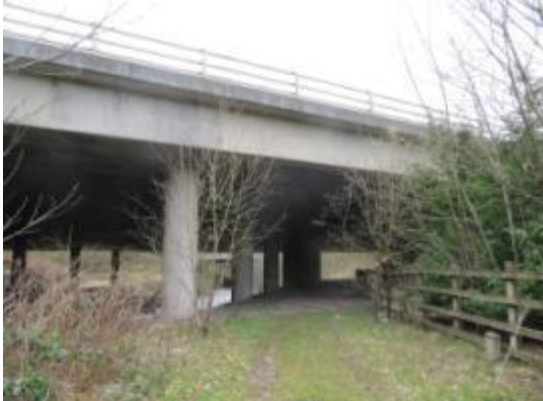
Location / OS Grid Ref.	Feature/description	Alternative access to avoid restrictions
NT081027	<p>Two underpasses in quick succession under the M74 and A701, river alongside. Ample height and width clearance, but riders may prefer to dismount and lead horses which may spook when heavy vehicles rumble overhead</p>

Follow main road around roundabouts and under motorway

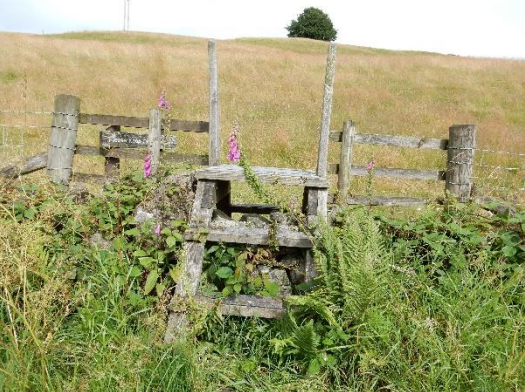
<p>NT092029 NT096029</p>	<p>Ladder stiles in fence</p>

<p>Follow quiet public road past Oakriggside and Newmills</p>
<p>NT100033 NT106042</p>	<p>Ladder stiles over dyke at road junction either end of path</p>

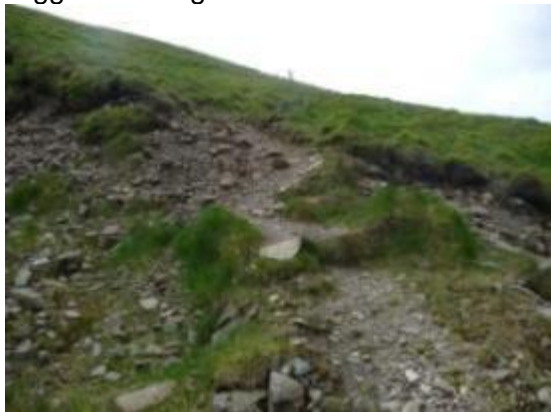
Location / OS Grid Ref.	Feature/description	Alternative access to avoid restrictions
NT163060	<p>Steep, narrow grass path, eroded in places. Passable with care with sure-footed horse but suggest leading</p>

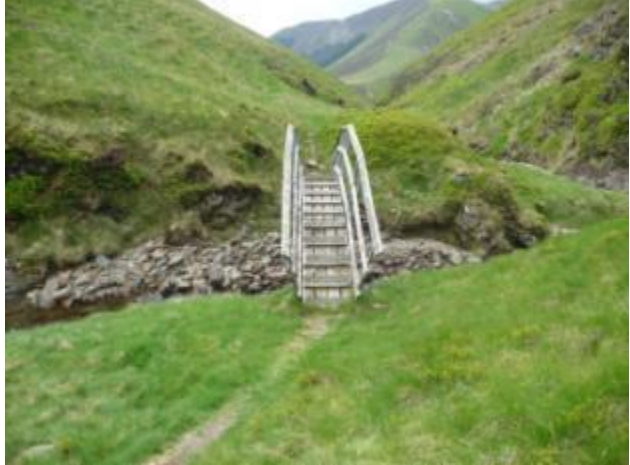
NT165062	<p>Steep narrow 70 cm wide wooden footbridge over rocky gully, unsuitable for horses. Metal supports projecting either side of the ends of the bridge restrict scope to cross the burn at this junction with a horse.</p>

<p>Ford burn upstream of bridge where banks less steep (where original path line and FB marked on map)</p>
NT165062	<p>Eroded crossing of small burn. Narrow and easily stepped over but care required.</p>

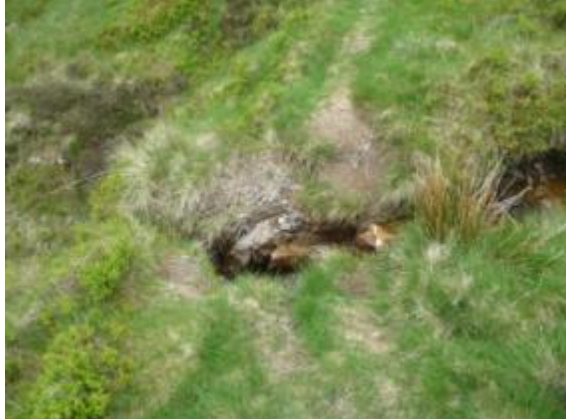
<p>NT167063</p>	<p>Eroded rocky gully. Passable with care with sure-footed horse but tricky footing and steep drop.</p>

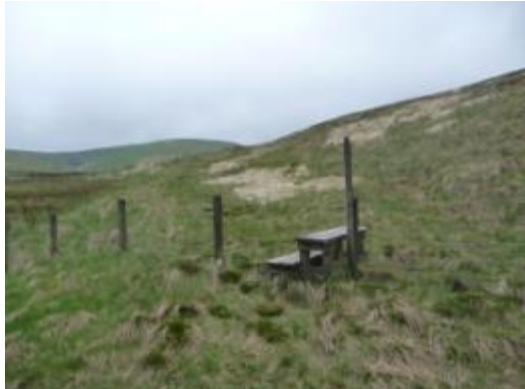
NT173064	<p>Wooden stile in fenceline</p>

<p>Scottish Borders Council are arranging replacement with a self-closing bridlegate. Meanwhile slip gate 50m south of stile but wet ground and ditches to negotiate inbetween</p>
NT174066	<p>1m wooden plank bridge over shallow ditch where path through conifers leaves track</p>

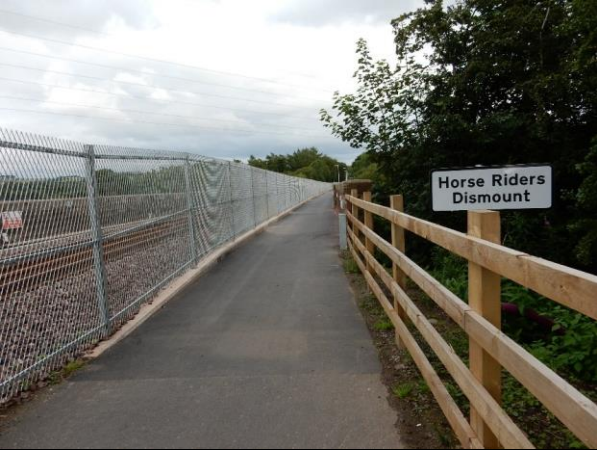
Netherbarns
NT504342 to NT511350	Narrow riverside path along River Tweed and Gala Water	Keep to minor road which runs immediately parallel to west
NT513313 Red Bridge, Tweedbank	<p>Southern Upland Way runs parallel to newly re-opened Waverley Way railway line, immediately behind high chainlink fence on picture below. Post and rail fence on opposite side. Passable with care, but riders should be aware of high level of pedestrian and cycle use and risk of trains in close proximity to path. Sign advises horse riders to dismount crossing bridge over Tweed in case horse spooks should a train pass as parapets lower than BHS recommended height of 1.8m.</p>

Continue north on public road to B6374, turn right (east) to rejoin SUW at Gattonside
NT535346	Pedestrian only suspension bridge.	River only suitable to ford in exceptionally dry summers. Alternative route from Galashiels: From B6374 junction west of Melrose, turn left heading north over River Tweed by road bridge, then first right on B6360, rejoining SUW at Mill Cottage
